Range Inspection Checklist Cover Sheet

Name of range: **SA Police Academy**

Date inspected: 10 October 2023

Pistol & Shotgun – law enforcement training

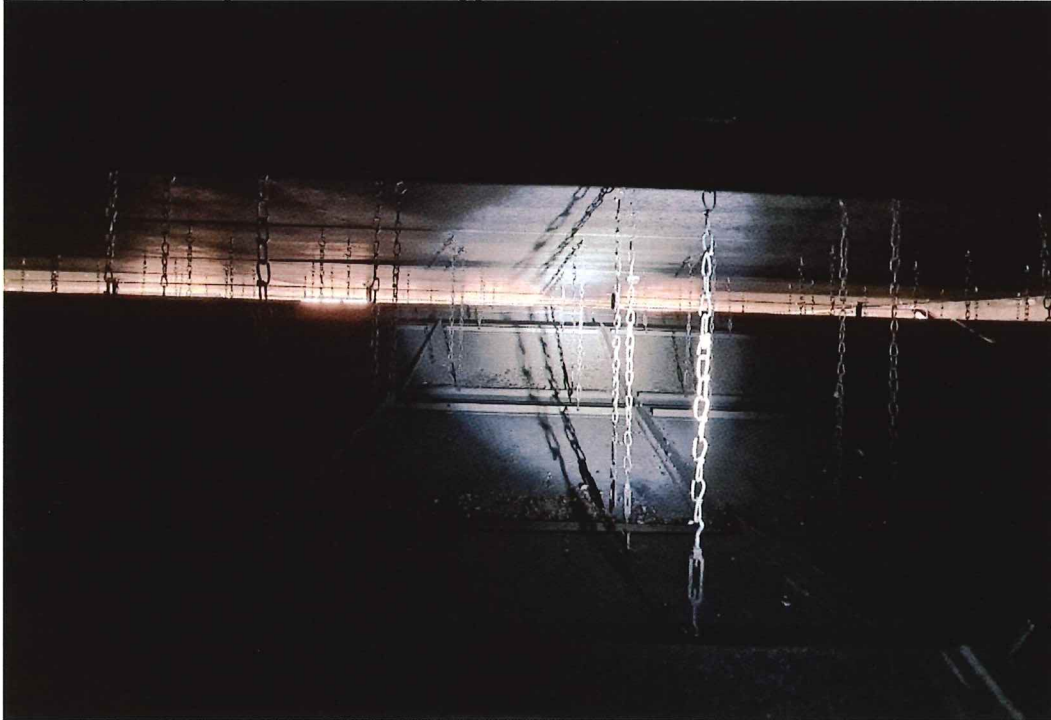
A high volume air extraction system is in use which is checked regularly. There is some consideration that the extraction system may be responsible for some projectile debris in the maintenance room as there is reasonable build up on top of the upper deflection plates.

1.1 Debris located on top of hanging upper deflection plates. As this has not been recorded in the past the origin is unknown. Suggestion would be to clean and monitor.

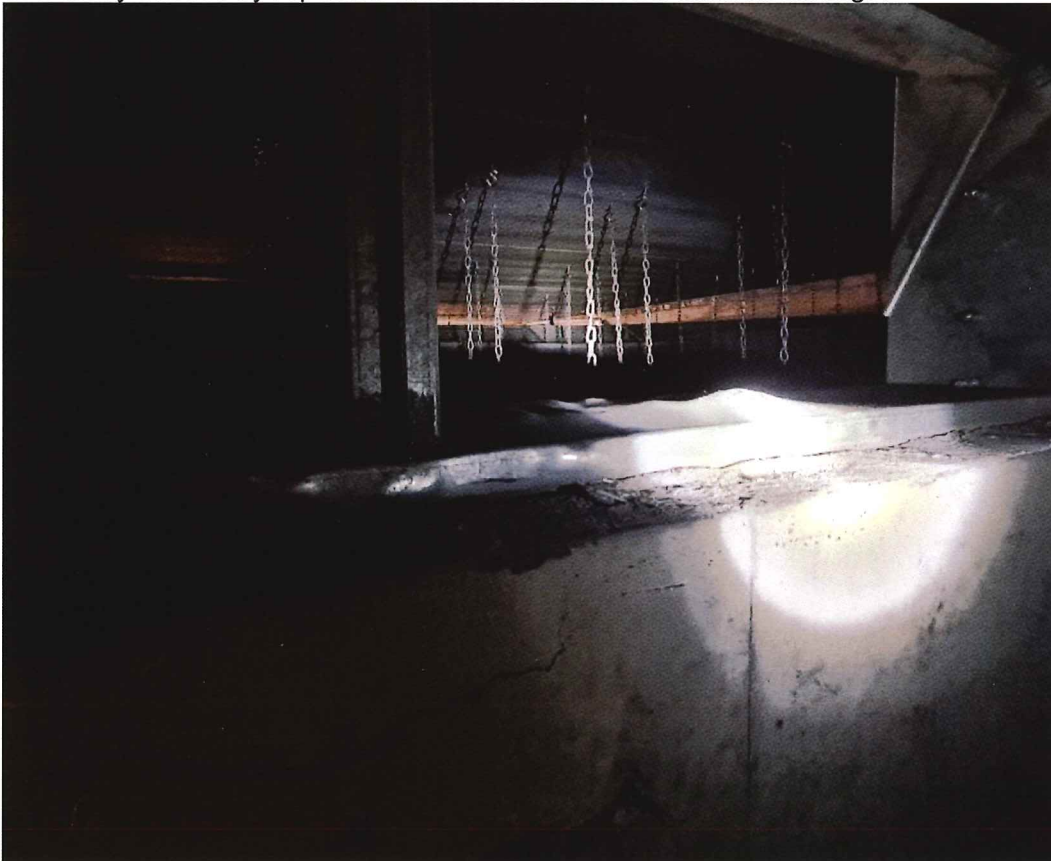
On investigation, staff located a section of deflector plate had become detached from the backstop structure, allowing projectiles to impact the concrete structure of the building. Over time, the projectiles had sufficiently damaged the concrete structure to form a significant hole, allowing exit into the maintenance room.

1.2 Vent housing showing impact damage from below, causing framework to buckle. Concrete on other side is significantly damaged. Lower right shows beginning of hole eventually caused by repeated strikes. Unable to view internal damage.

- The concrete affected by the backstop fatigue is to be repaired.
- Ballistic blocks will be installed above the ventilation system to ensure capture of any stray projectiles should this issue occur again – 12 months to install.
- Walls in the maintenance extraction room to be painted / papered to monitor any new markings post repair work.
- Ballistic blocks to be placed across range floor to inhibit ricochet as matter of urgency. To be monitored for at least three months as this issue may be a side-effect of the backstop failure.
- Thorough cleaning of all affected areas and monitor to determine whether overshoot is still occurring.
- SAPOL will provide photos of existing deflector plates etc when additional work is completed October 27th.

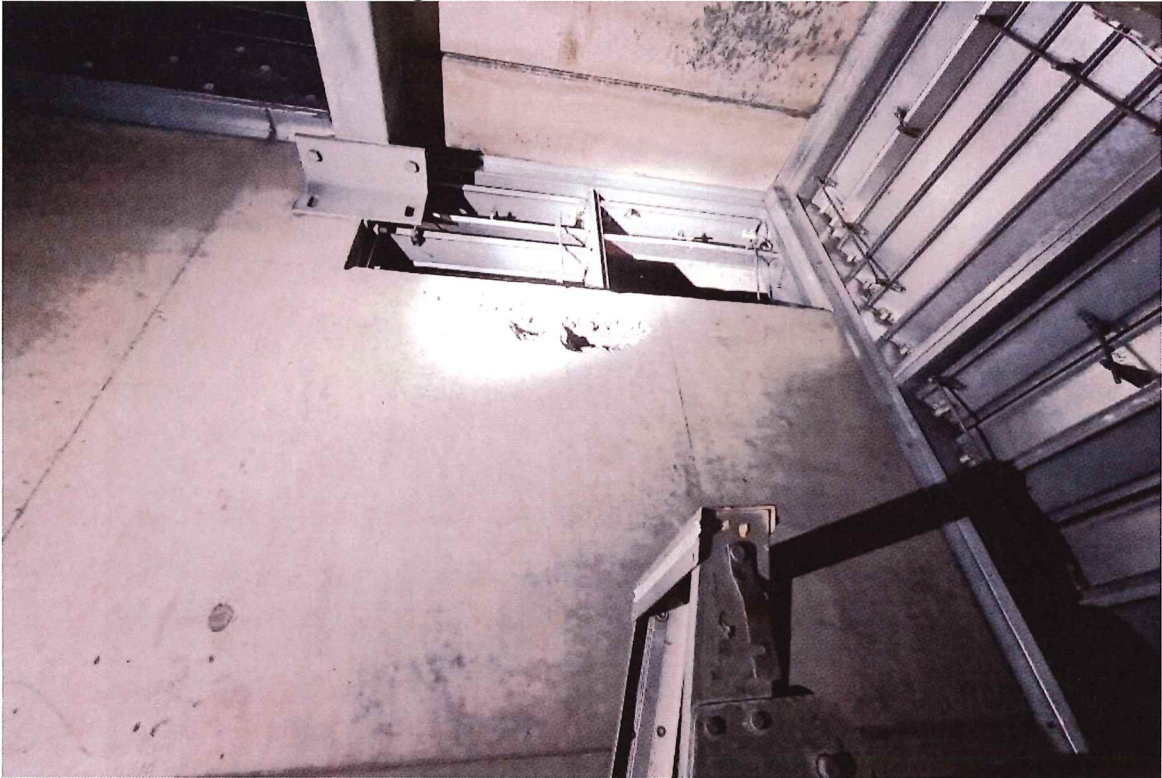
1.3 Hole in concrete visible from ground level

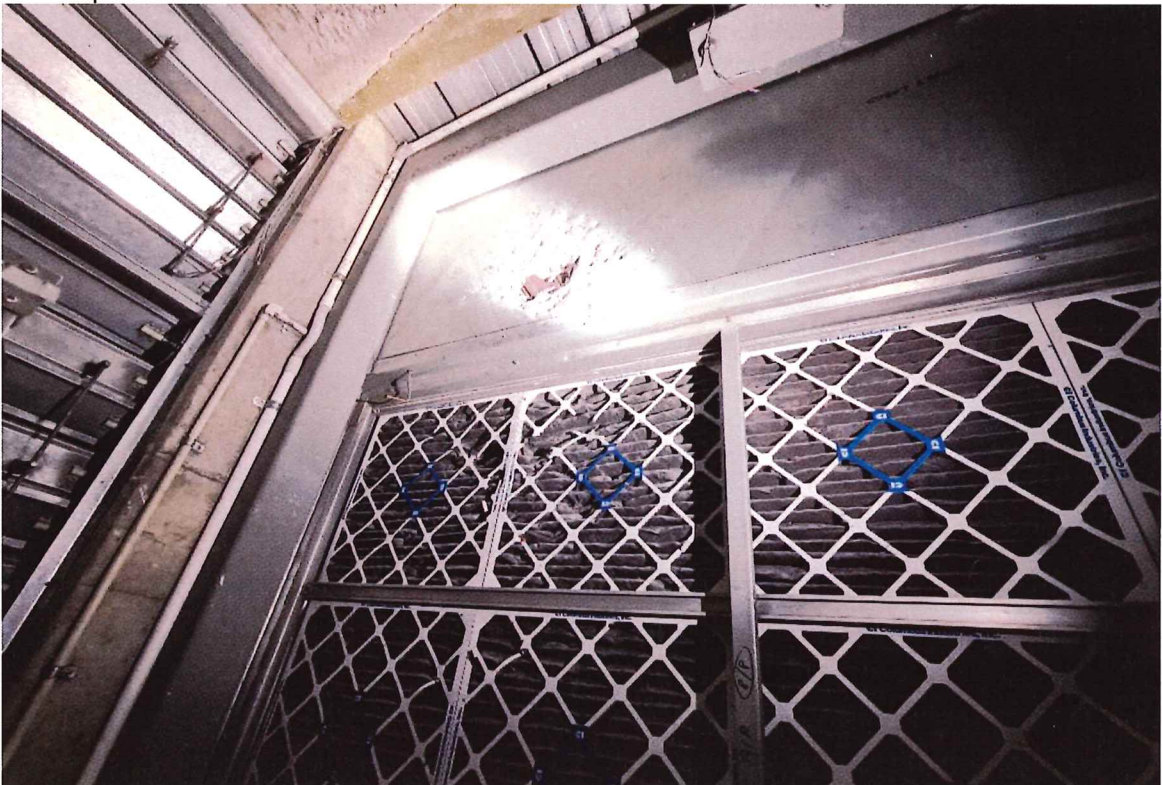
1.4 Multiple exit points through metal cladding and ventilation mesh. Note marking on ceiling from repeated strikes.

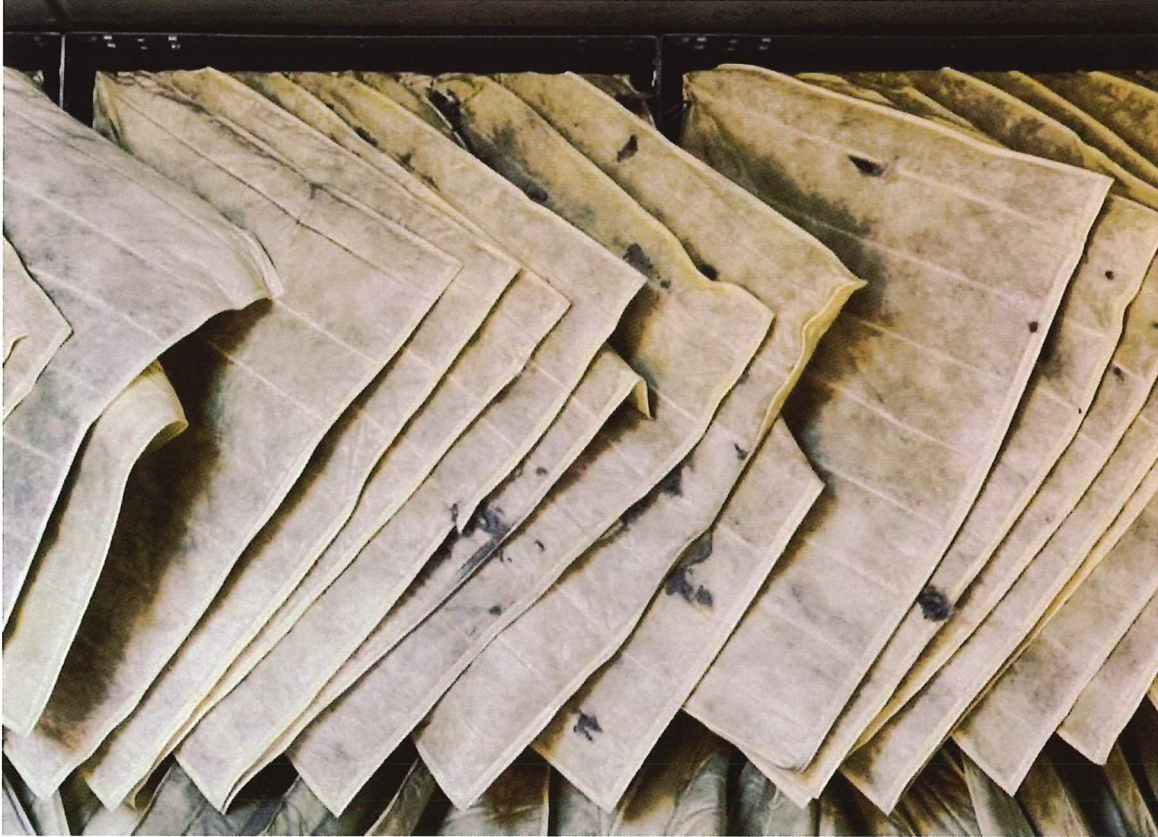
1.5 Ventilation mesh damaged by projectiles. Burn marks and holes clearly visible.

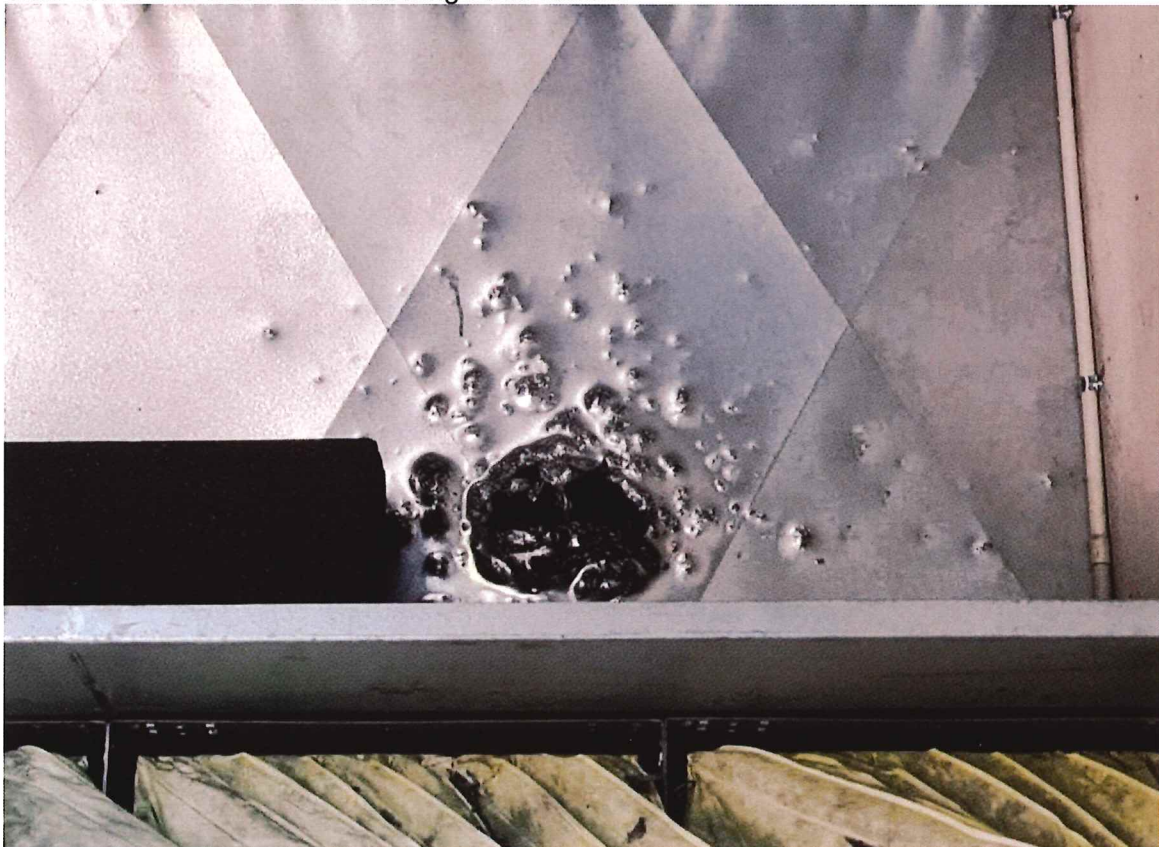
1.6 Hole in metal cladding above ventilation padding. Black ballistic block was put in place once issue was discovered and range was closed.

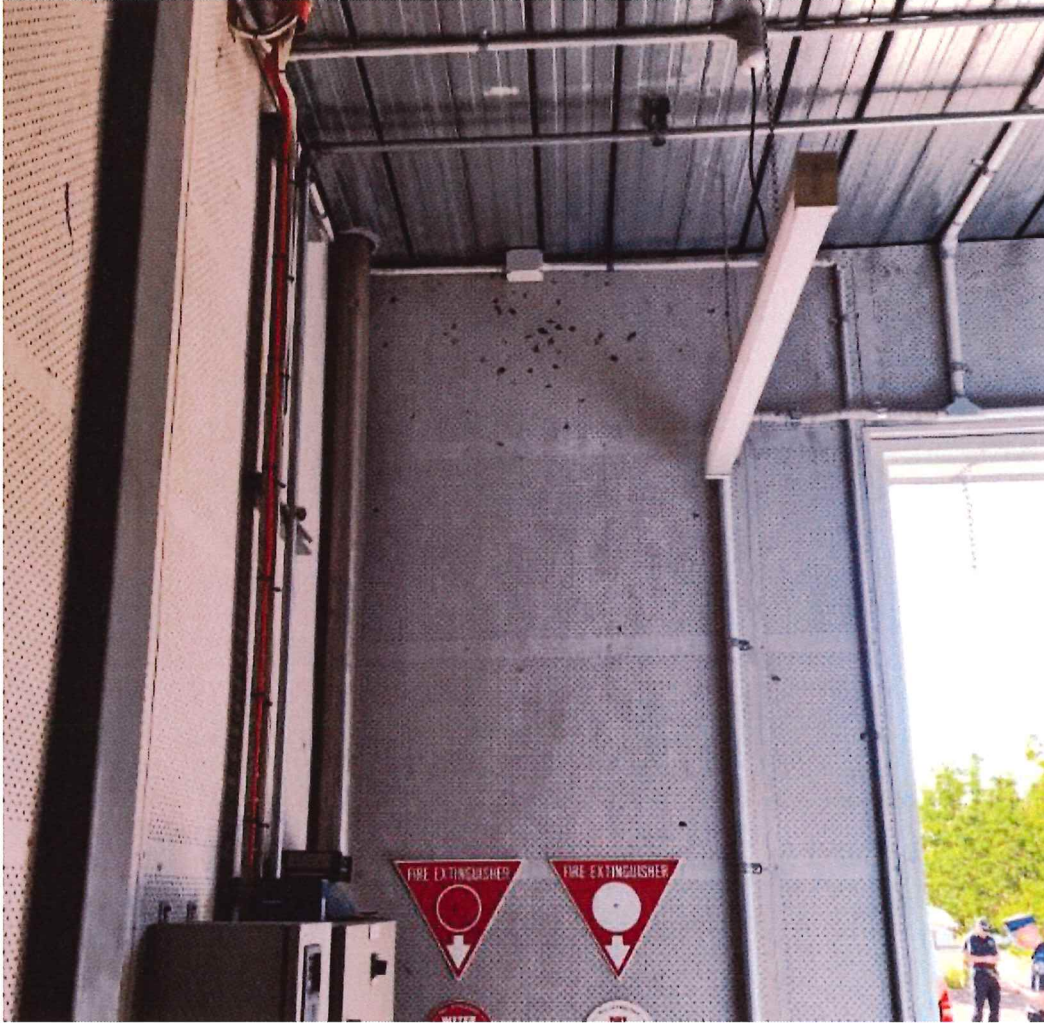
It should be further noted that complaints have been made regarding ricochet and particles falling up-range and being found in the maintenance room opposite the existing hole.

1.7 Damage caused to wall directly across from exit hole. Most recent damage was caused yesterday prior to range closure.

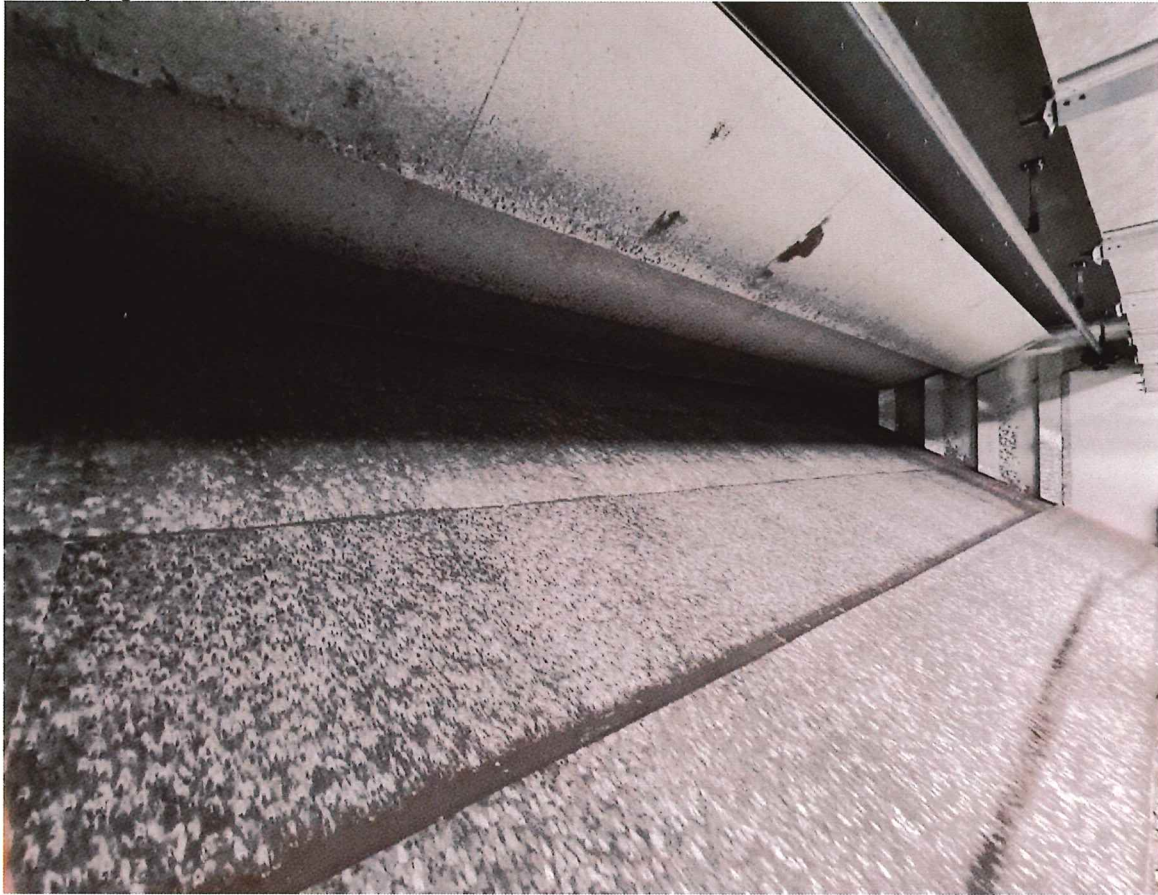
1.8 Bullet trap. Note overlapping plates which allow some debris to filter through plates into underlying structure.

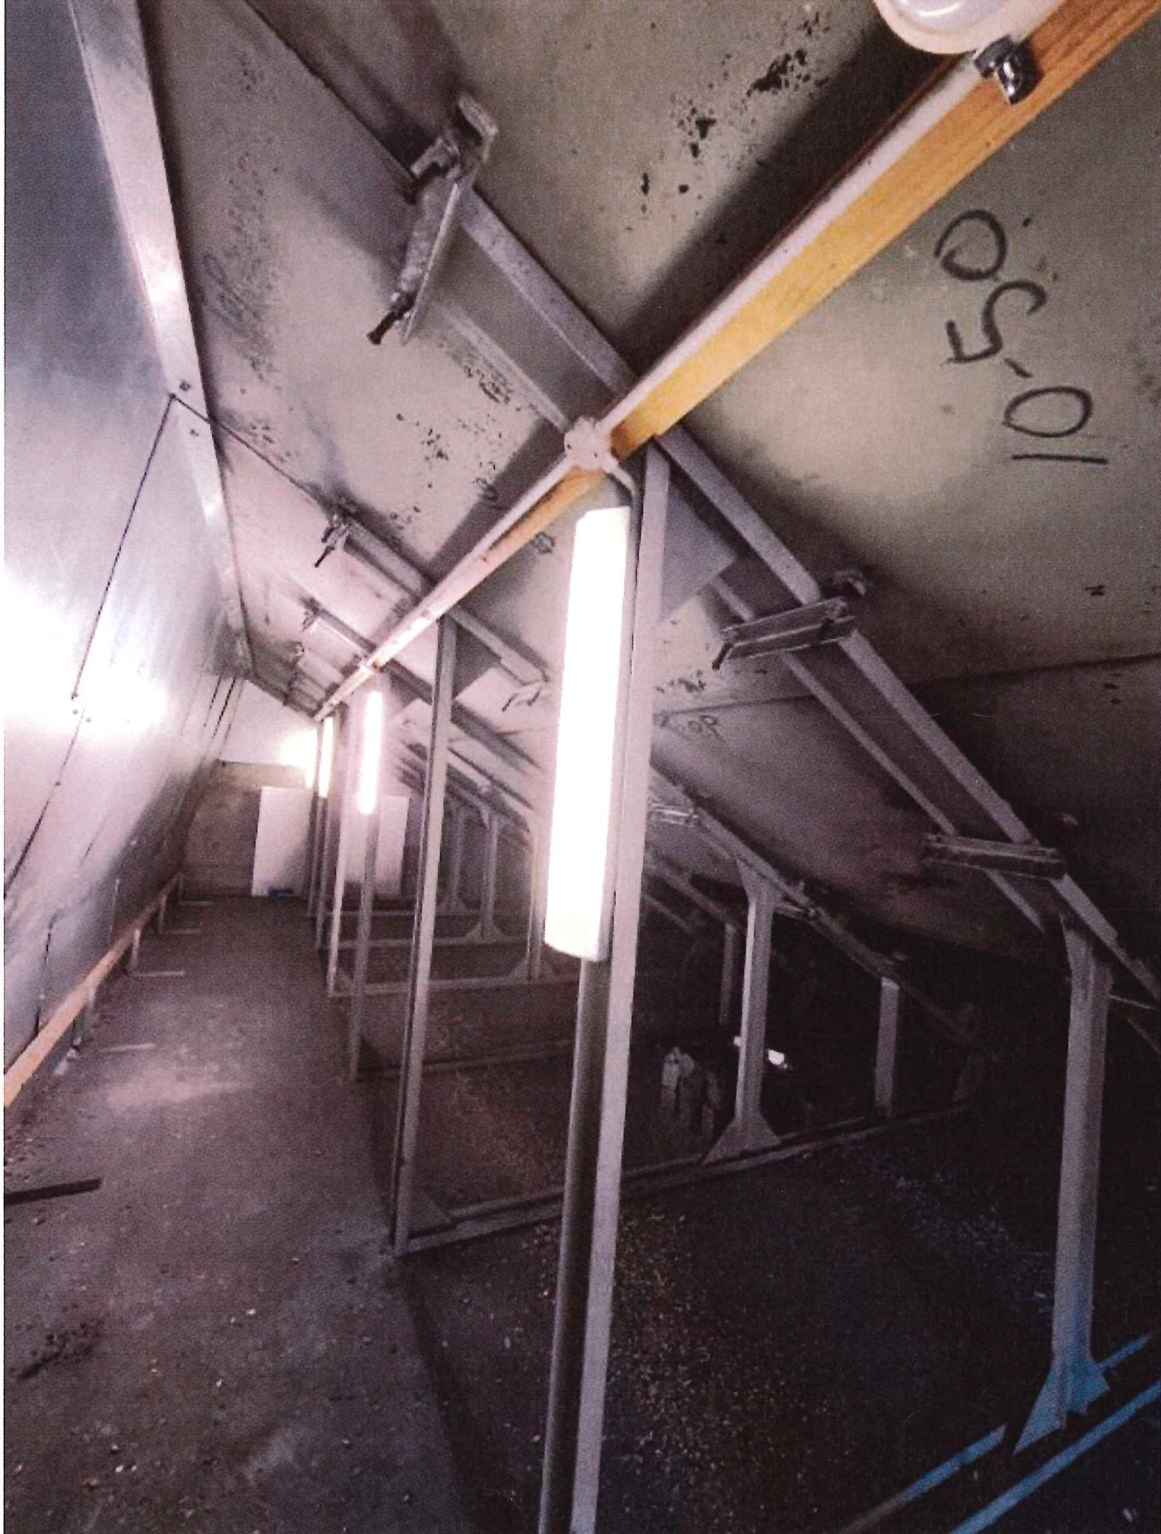
The SAPOL design appears to culminate in a steel plate which projectiles impact with and then fall into what is essentially a strengthened cavity. This hinders inspection of the structure as the steel plates covering the cavity need to be removed prior to lead collection and inspection. I was advised onsite that lead collection occurred infrequently with this being the first collection in decades.

1.10 Underneath floor plates with opposite "projectile capture" sheeting. This must be removed to inspect deflection plate which failed and recycle lead.

at 600,000 rounds per year at full capacity, I would high recommend maintenance and inspection should not exceed 12 months.

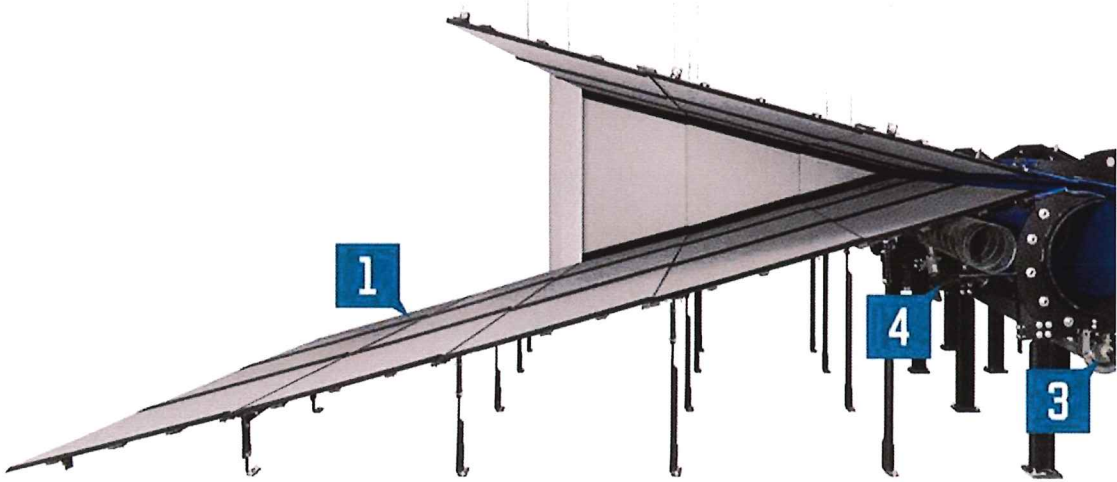
The previous report describes the backstop as a CASWELL design, made of 10mm toughened steel plate. In my investigation however the design more closely replaces a Total Containment Trap (TCT) design (see image 1.11) with steel plates angled from the floor and ceiling to funnel projectiles into a central trap. Here it varies however as the TCT design normally culminates in a deceleration chamber where all projectiles are captured and removed via a bullet collection system.

1.11 example Total Containment Trap construction
